**INVESTIGATING AMOUNT OF LEAKAGE, SEDIMENT AND DURABILITY IN
GEOSYNTHETIC COVER OF PUMPING CHANNEL 3 AT IRRIGATION
NETWORK OF MOGHAN**

ABSTRACT

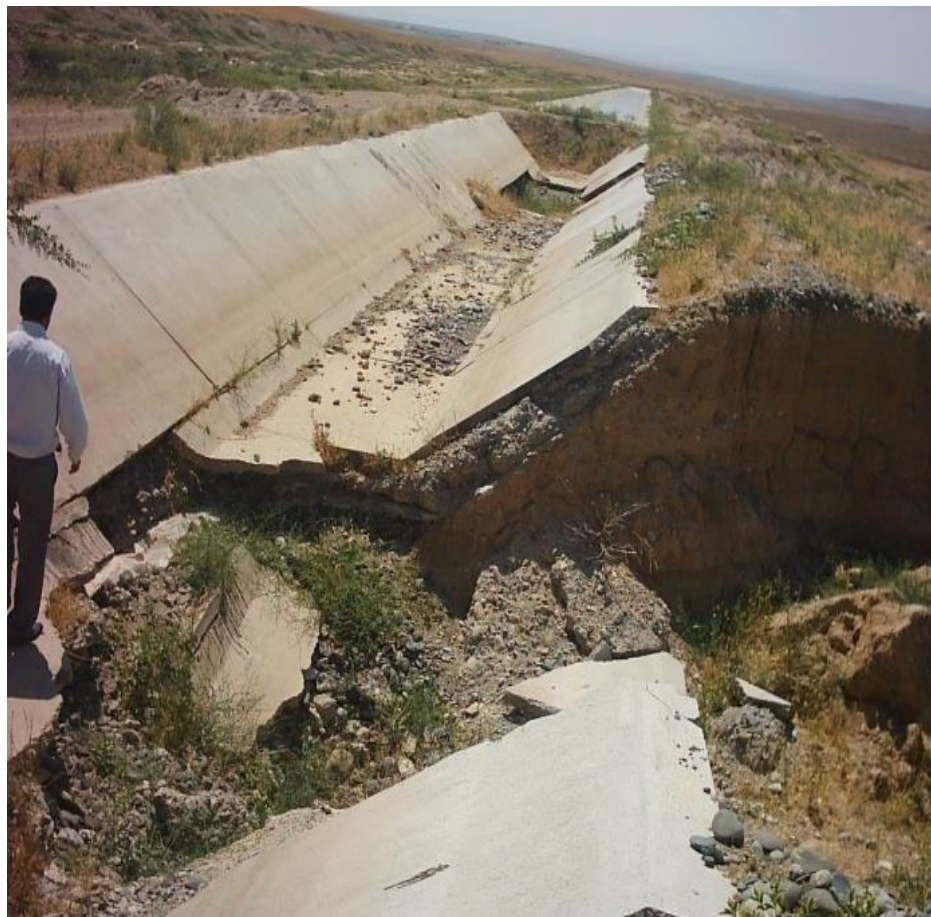
Figure 3: The destruction of pumping channel 3

The irrigation and drainage network of Moghan was designed and developed in 1355-1362. After descending and a ten years exploitation period, the channel's floor and walls were cracked and damaged. Because of these problems, the exploiting operation became difficult. In 2001 three critical areas of 8 kilometers were repaired and restored. After less than two years of operation, severe damages were reclaimed in the modified areas. In addition to the removal of damaged bottom soil, the channel has been geotextiled with geomembranes

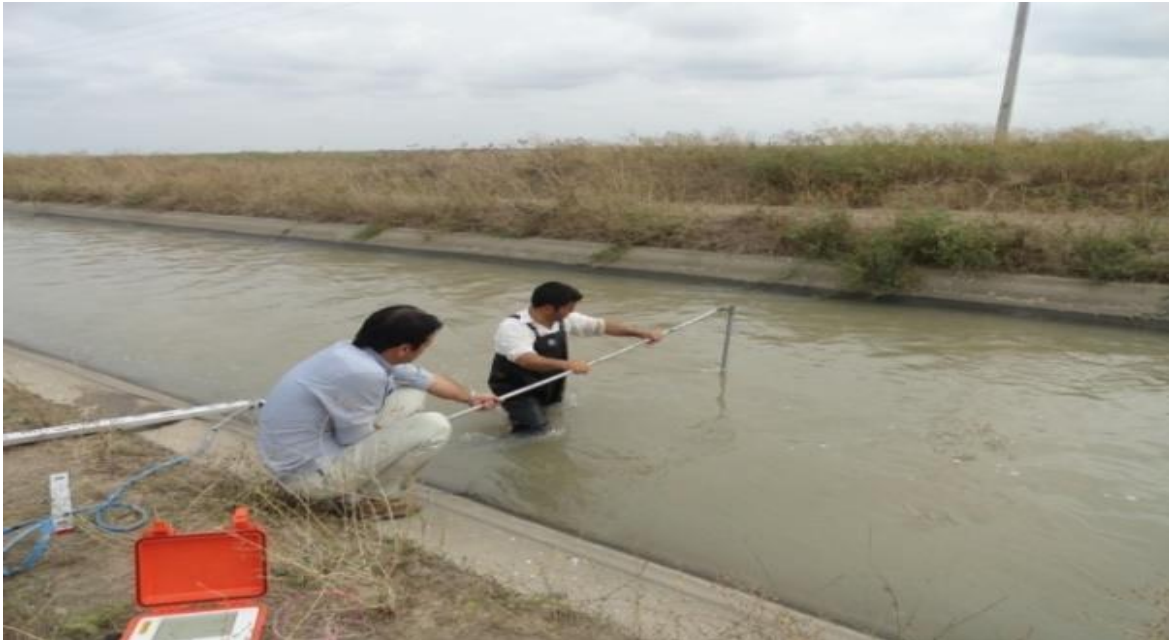
Figure 4: Flow measurement to determine the leakage rate by ultrasonic device

channel, the following studies were carried out to evaluate the hydraulic and technical properties of geosynthetic covers. Measurement of water losses through leakage from body and wall of channels was done by using the input-output method.

Although the pond test has a higher accuracy than this method, but the input-output method was selected due to the need to interrupt in operation of channel and closing the channel at the beginning and the end of the considered domain. Thus, the difference between the amount of entered water to a domain of channel and amount of released water from it is considered as leakage losses. For this purpose, a domain of 1900 meters was selected and amount of leakage in this domain was measured and averaged in different discharges and with three replications in each discharge. It was noted that the flow discharge rate in the channel was measured by using an ultrasonic flow meter. By measuring the water level of channel in desired domain and evaporation from pan (by using weather data), the total amount of evaporation from channel was obtained.
